Manhole Inspection Summary

Manhole # S15QQ1025MH

Location Address: **2601 OAKLEY AVE**

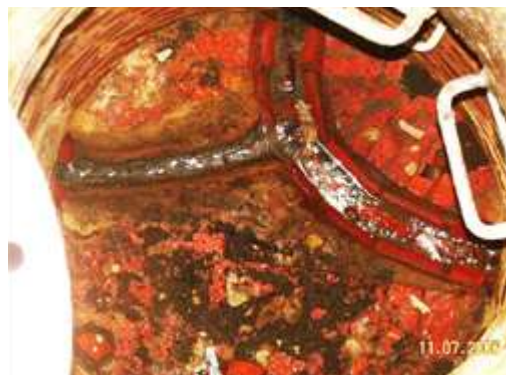
Top View

☒ **Debris** (not Condition related)

Bench debris.

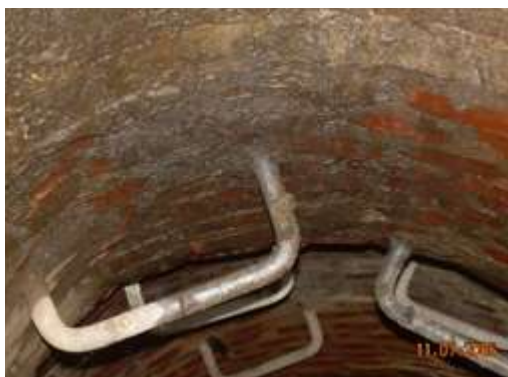
Defect

☒ **Leaks**

Infiltration: ☐ None ☒ **Joint** ☐ Cracks ☐ Mortar ☐ Roots ☐ Wall

Frame leaks. Adjustment infiltration.

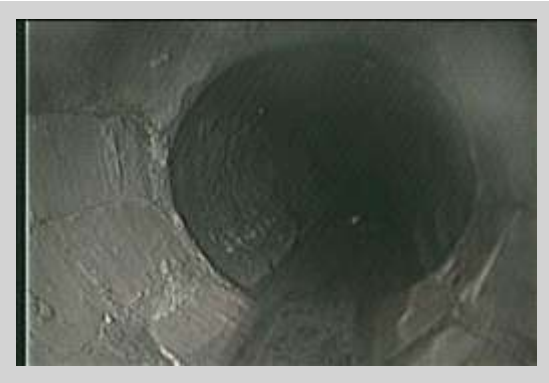
8 in. Circular Gravity Sewer Pipe Out @ 12 O'Clock

Invert Depth: **9.29** (ft.) Flow Characteristics: **Slow**

Infiltration: **None** Pipe Seal Cond: **Unknown**

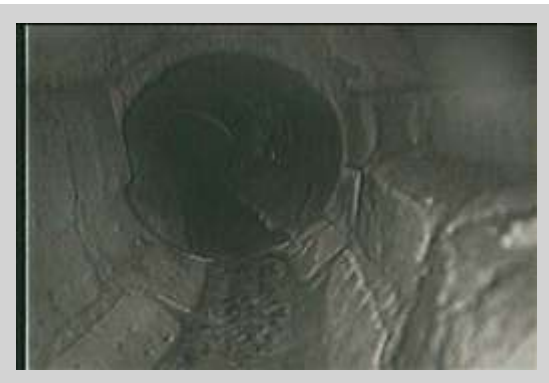
8 in. Circular Gravity Sewer Pipe In @ 4 O'Clock

Infiltration: **Evidence** Pipe Seal Cond: **Unknown**

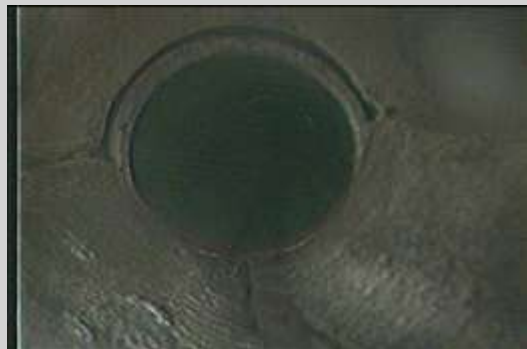
Pipe In @ 9 O'Clock

Infiltration: **Evidence**
